GREAT WESTERN NETBALL COURT FACILITY CONDITION & COMPLIANCE AUDIT REPORT.

Prepared By: 2MH Consulting.

13/1/17, 11:28 am

5 Cubitt Street
Great Western VIC 3377
Australia
(-37.15289644900444, 142.8521319386948)

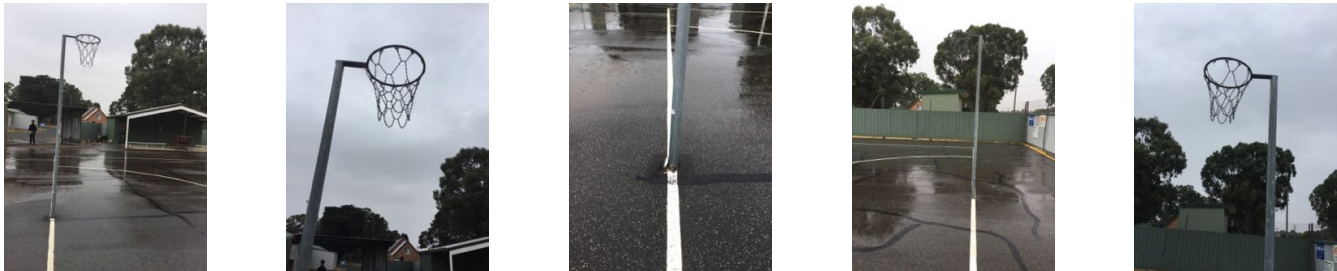
<div style="display: flex; justify-content: space-around; margin-top: 5px;"> 48 49 50 51 52 </div>

Question	Response	Details
Goal Post and Ring type	Round post, Fitted into sleeves, Raw finish, Galvanised steel ring, Flat steel sheet joinery between ring & post, No arms from ring to post	
Goal post Rating	4 - Good	
Is there padding fitted?	Padding not installed at time of inspection	
Is there a net fitted?	Yes, Raw Steel Mesh	
Does the Goal Post impede on the Court Playing Area?	No, inside enclosure	
Rust present around post base or ring mouth?	No	
	The goals are in good condition and fit for purpose, however, they have non-compliant heights. The Eastern end is 10mm too high and the Western end is 10mm too low.	
Goal Photos

- Either reuse and modify the existing goal posts so that they achieve a compliant goal post/ring height of 3050mm or install new compliant 3050mm high goal posts into sleeves with lockable covers. These must finish flat with the surrounding pavement and have a textured surface consistent with the court surface so as to not cause a trip or slip hazard when not in use. The goal posts should have a locking pin so that the posts do not move around in the sleeves when in use. If the courts have the potential to be public access courts then a strengthened ring connection may be necessary. The goal post should not extend past the goal ring height and there should be no arms from the ring to the post.

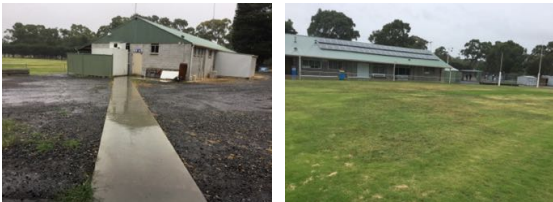
<p style="display: flex; justify-content: space-around;"> 62 63 </p>		
COURT SURROUNDS & CARPARKING

<p style="text-align: center;">61</p>		
CLUBHOUSE/CHANGEROOM		
Does the facility have a Clubhouse?	Yes	
What is the estimated distance from the court(s)	20-30m	
Clubhouse size	Small	
Was the clubhouse inspected?	No	
Clubhouse notations	The Football/Netball clubrooms are located to the North West of the netball court. They are utilised by both the football and netball players.	
Clubhouse photos

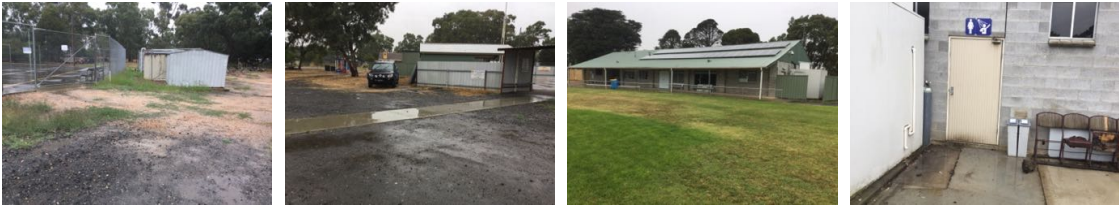
Question	Response	Details
Location of Netball Facility	Sports Reserve	
Court surrounds / Adjacent land comments	<p>The netball court is located on the Western side of the Great Western Recreation Reserve.</p> <p>The football ground is located to the North West of the netball court and the main carpark area is located to the North.</p> <p>The grounds are a little unkept, this is likely to be due to the audit taking place in the off season.</p>	
Court Surrounds Rating	3 - Average	
Court Surrounds Photos
