GREAT WESTERN NETBALL COURT FACILITY CONDITION & COMPLIANCE AUDIT REPORT.

Prepared By: 2MH Consulting.

13/1/17, 11:28 am

5 Cubitt Street
Great Western VIC 3377
Australia
(-37.15289644900444, 142.8521319386948)

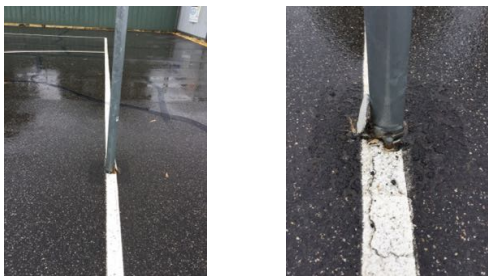
Question	Response	Details
Goal Post and Ring type	Round post, Fitted into sleeves, Raw finish, Galvanised steel ring, Flat steel sheet joinery between ring & post, No arms from ring to post	
Goal post Rating	4 - Good	
Is there padding fitted?	Padding not installed at time of inspection	
Is there a net fitted?	Yes, Raw Steel Mesh	
Does the Goal Post impede on the Court Playing Area?	No, inside enclosure	
Rust present around post base or ring mouth?	No	
	The goals are in good condition and fit for purpose, however, they have non-compliant heights. The Eastern end is 10mm too high and the Western end is 10mm too low.	
Goal Photos
